Spring 2018 Service Dealer Guide Volume 1

Power Take Off Assembly

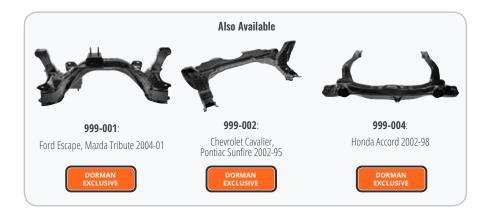
OVER 100 SKUS AVAILABLE

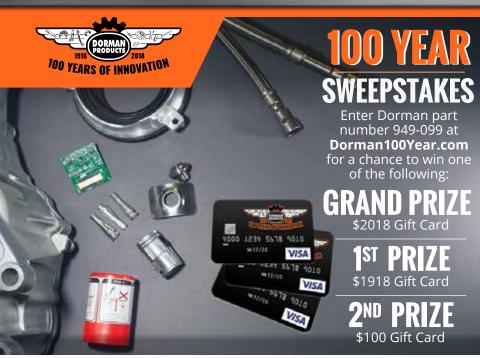
NO PURCHASE NECESSARY. Purchasing will not improve your chances of winning. Sweepstakes is not open to the general public. The Sweepstakes is only open to auto-industry professionals who are legal residents of the 50 U.S., including D.C., and Canada (excluding Quebec), ages 21 and older. Void in Quebec, outside the U.S. and Canada and wherever prohibited by Jaw. Starts at 12:00:01 AM ET on 5/15/18 and ends at 11:59:59 PM ET on 6/30/18. Visit www.doman100year.com for Official Rules. Sponsors: Dorman Products, Inc., 3400 East Walnut Street, Colmar, PA 18915 and Dorman Canada, 3625 Avenue des Grandes Tourelles, Boisbriand, QC J7H 0E2.
